AIRCRAFT ACCIDENT INVESTIGATION, F/A-22 S/N 00-4014

**422nd TEST AND EVALUATION SQUADRON
NELLIS AIR FORCE BASE (AFB), NEVADA
20 DECEMBER 2004**

F/A-22A ACCIDENT

20 December 2004

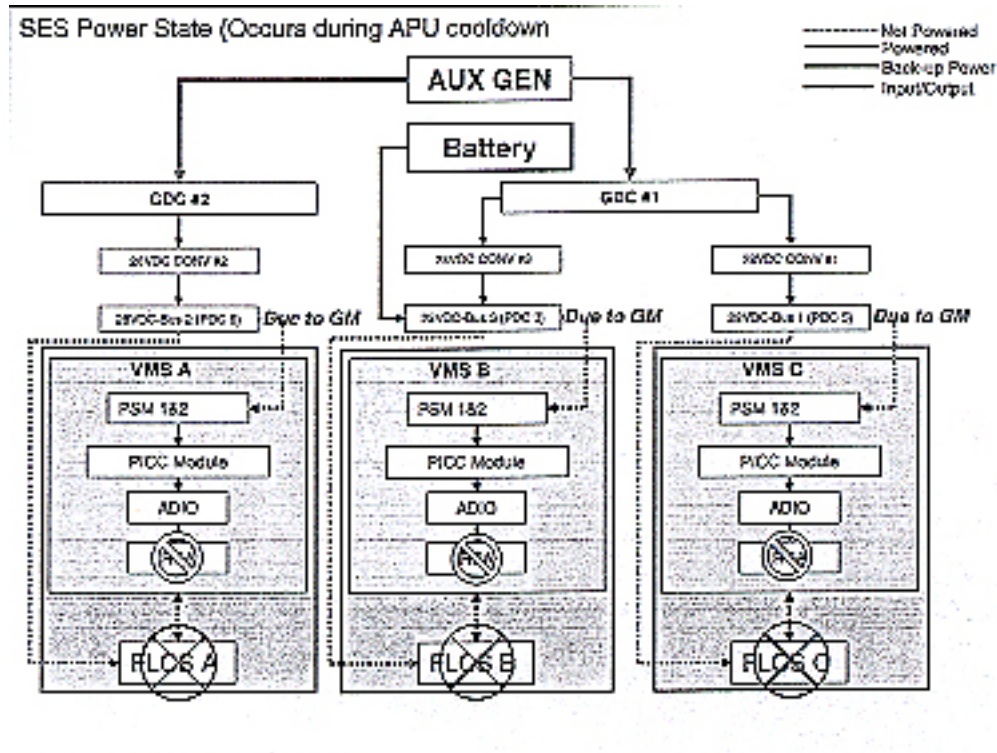
SES power state is apparent on CSMU data. On the last frame of CSMU data, all four converters on Power Distribution Centers (PDC) 5 and 6 (270 volts DC Buses 3 and 4) indicated “good”. This indicates good APU generator operation. However, it does not show whether the APU was operating in 22 kw (run) or 5 kw (SES) mode. The last frame of CSMU data also showed the removal of 115 volts AC Inverter Signals from PDC 7 and 8. These inverter signals are passed via PDC 5 and 6 (which are powered regardless of APU run mode) and show the removal of 115 volts AC power. This combination of converter/inverter signals clearly shows that the APU was operating in the 5 kw SES mode (Tab CC-5) (Tab BB-3 through BB-7). In the SES power state (ground operations only) the FLCS does not receive power. The next paragraph describes how electrical power is removed from the FLCS while in the SES power state.

Figure 1-SES Power State-Power Distribution to FLCS (Created by AM Pilot Advisor)

While the APU is in SES mode (aircraft in SES power state) of operation (5 kw output), both Generator Distribution Centers (GDC) remain powered. In addition, 28 volts DC Buses 1, 2, and 3 receive power from their associated 28 volts DC converters. Global Management (GM), software control for all aircraft operations, removes power to the FLCS computers and portions of the Vehicle Management System (VMS). Each of the three FLCS branches has its own associated VMS. Within each of the three VMSs, is a Rate Sensor Assembly (RSA). RSAs measure angular acceleration in all three axes, pitch, roll, and yaw. These RSAs require power to provide a valid output (Tab BB-3 through BB-7).

Once GM sensed the aircraft was in SES power state (on the ground), power was removed from Power Supply Modules (PSM) 1&2 in the VMS. Therefore, no power was supplied to the Processor Interface Controller and Communication (PICC) module, the Analog Digital Input/Output (ADIO), and the associated RSA in turn. We now know that power was removed from the RSAs. The length of time they were without power is an important factor.

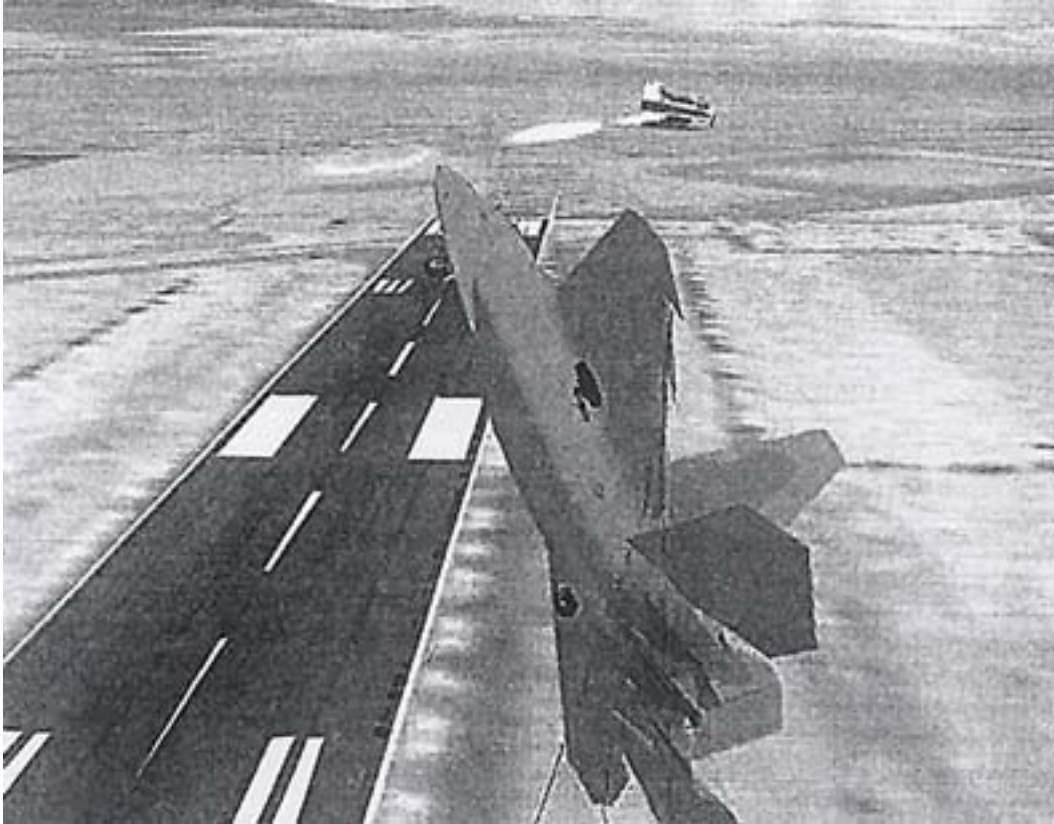
- Angle of Attack: -4.4 degrees
- Sideslip: -39.0 degrees (nose left) • Pitch : 25 degrees nose up
- Roll: 56 degrees ring wing down (continuing to roll more right wing down)
- Magnetic heading: 002
- Airspeed: 210 Knots Calibrated Airspeed (KCAS)
- Altitude: 2360' (approximately 500 feet above the ground)

Figure 2 — Recreation of Aircraft Parameters at Ejection (Tab S Video)

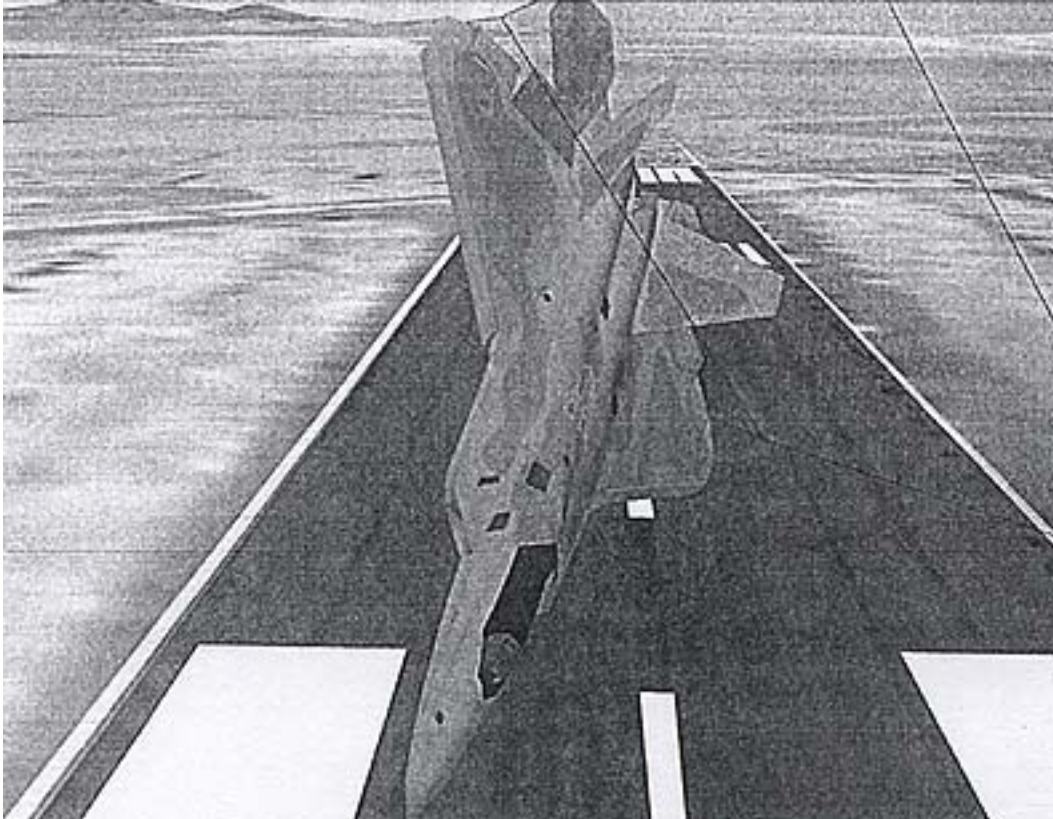
- Angle of Attack: 90 degrees
- Sideslip: -45.0 degrees (nose left)
- Pitch : 35 degrees nose up
- Roll: 71 degrees left wing down
- Magnetic heading: 223

Figure 3 — Recreation of Aircraft Parameters at Impact (Tab S Video)

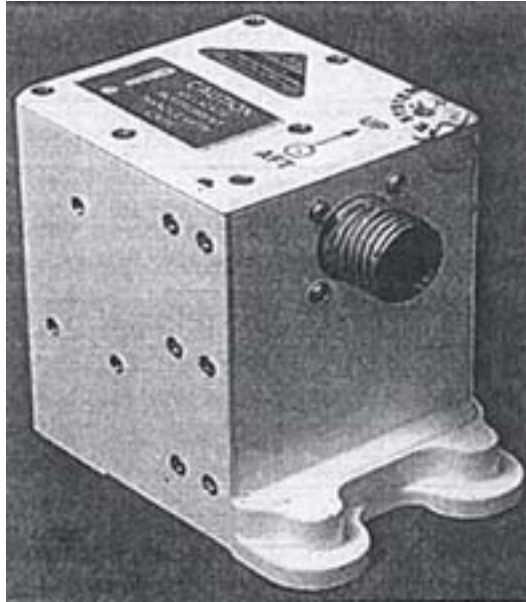
Figure 4 — RSA

This momentary interruption of power to the RSAs at approximately 1516:20 caused all three to "latch". This latched state nullified their output (Tab CC-5). See Section 6a for a description of RSA latching. CSMU data confirms RSA latching. Prior to the power interruption at approximately 1516:20, all three RSA outputs were correct (Tab CC-5). At 1522:45 the right engine was commanded to start by moving the throttle from OFF to Idle. This command restarted CSMU recording. From the first frame of data at 1522:45 to the last frame of data at aircraft impact, all three RSAs showed a 0.0 output. Continuous 0.0 output indicates a latched RSA (Tab CC-8). Unfortunately, the MP was unaware of this condition (Tab V-5.10 through V-5.13).

LMA was aware of occasional RSA latching at startup since 2002. This latching condition is due to a pin used by the manufacture to get the unit into the test mode. This pin connects to a Universal Asynchronous Receiver Transmitter (UART) chip. The UART is looking for a leading edge 5 VDC square-wave trigger to get the unit into test mode. With this pin left “floating” the RSA can latch in the test mode on power-up or cycled power.

Approximately 20 -101 RSAs had been returned to the supplier for suspected latching. Most had been single failures with one double RSA failure. All occurred on the ground and had been detected by built-in-test. LMA determined the probability of a catastrophic airborne triple RSA failure to be extremely low and developed a latching fix. This involved adding a pull-up resistor to give a constant Sv signal to the UART, ensuring the leading edge trigger will never be seen by the UART. In June 2004, Lockheed Martin submitted a charge request which added the latching fix to an ongoing RSA upgrade plan. The improved RSA, designated the -103, was to be gradually retrofitted in all F/A-22s through TCTO 1F/A-22A-654 (Tab J-11, J-26).

Time Compliance Technical Orders (TCTO) status was reviewed. Of relevance to the mishap is TCTO 1F/A-22A-654, which would have replaced all three RSAs, Part Number 553500-01, installed on MA with Part Number 553500-02 which is an upgraded RSA. The TCTO was not yet accomplished and parts were on order. The grounding date for this TCTO was 15 May 2006. RSA serial numbers and part numbers were extracted from the IMIS Hardware and Software Configuration pages from the PMA and the CAMS print out. The MA's RSA part numbers were 553500-01, serial numbers 002, 009, 026 (Tab U-3, U-4).

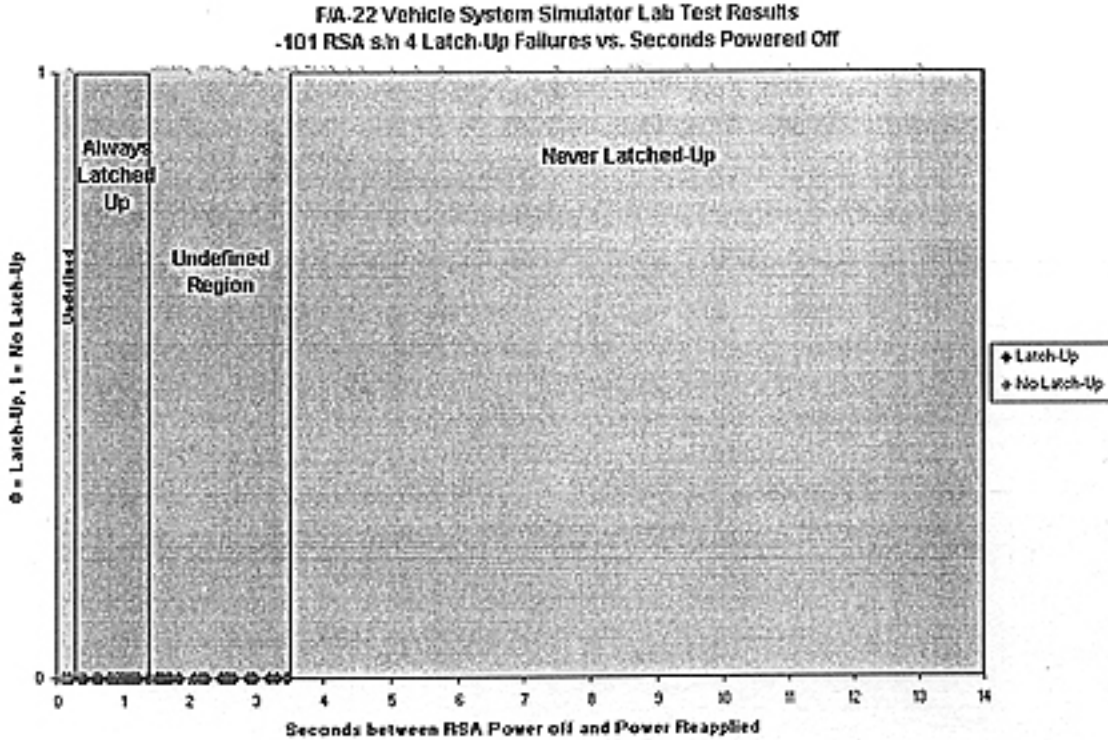
Post-mishap testing revealed the potential for triple RSA latching. After MA's CSMU data showed zero output from all three RSAs, LMA Air Vehicle Systems engineers conducted tests to better characterize what had previously been described as a random tendency to latch at startup. Extensive power cycling tests were performed in the VSS at LMA Fort Worth. The VSS had been used in the past to duplicate the latching characteristic of the -101 RSAs.

The -101 RSAs were installed in an F/A-22 flight control system simulator and the power switched (on-off-on) over a range from a few milliseconds to 16 seconds. Testing determined that the probability of -101 RSA latching depends on the length of time power is lost: less than 1.6 seconds the failure almost always (99%) occurs, from 1.6 to about 3.5 seconds the chances are 50%, and from 3.5 seconds on the latching do not occur. -103 RSAs did not latch during the testing (Tab J-10).

Figure 5: Data was taken in the VSS on a -101 configuration RSA to identify variables affecting the latch state. The data was taken by removing power to the RSA, then reapplying power and checking to see if the event resulted in a latched state. The span time from power removed to power reapplied is plotted as the x-axis. The state of the RSA is plotted as the y-axis (0 for latched; 1 for normal state) (Tab J-28).
